DEPARTMENT OF TRANSPORTATION

Contract #: 04-0120F4Cty: SF/ALA Rte: 80 PM: 13.2/13.9File #: 1.28**WELDING INSPECTION REPORT****Resident Engineer:**Pursell, Gary**Address:** 333 Burma Road**City:** Oakland, CA 94607**Report No:** WIR-012227**Date Inspected:** 18-Feb-2010**Project Name:** SAS Superstructure**OSM Arrival Time:** 700**Prime Contractor:** American Bridge/Fluor Enterprises, a JV**OSM Departure Time:** 1530**Contractor:** American Bridge/Fluor Enterprises, a JV**Location:** Job Site

CWI Name:	Mike Johnson, Steve McConnell, Jesse Prescott			CWI Present:	Yes	No
Inspected CWI report:	Yes	No	N/A	Rod Oven in Use:	Yes	No N/A
Electrode to specification:	Yes	No	N/A	Weld Procedures Followed:	Yes	No N/A
Qualified Welders:	Yes	No	N/A	Verified Joint Fit-up:	Yes	No N/A
Approved Drawings:	Yes	No	N/A	Approved WPS:	Yes	No N/A
				Delayed / Cancelled:	Yes	No N/A
Bridge No:	34-0006			Component:	SAS OBG 1E/2E

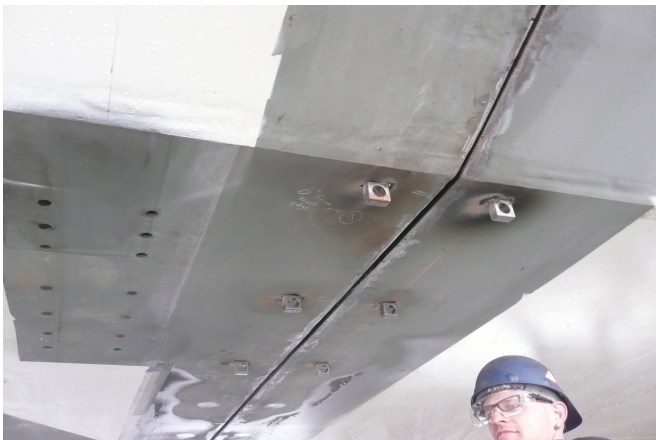
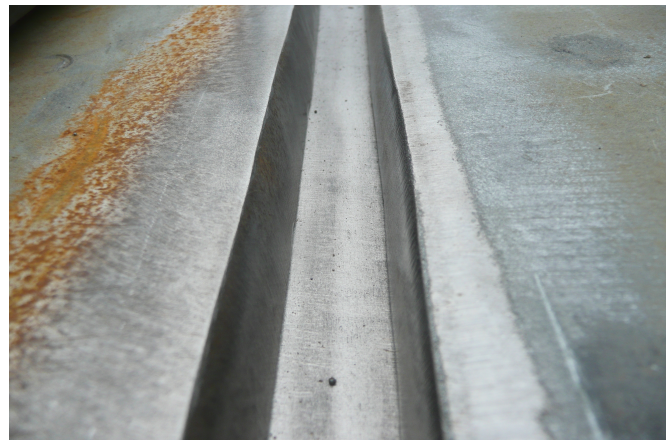
1E/2E-A steel backing

The QA Inspector randomly observed the ABF welders Mitch Sittinger and Jordan Hazelaar along with additional ABF helpers fitting up the steel backing for the above identified weld joint. It was noted the steel backing for 1E/2E-A will remain in place after welding is completed (pictured below). The QA Inspector noted the steel backing being installed was previously welded and ultrasonically tested (UT) by SE QC and randomly verified by Caltrans QA. The QA Inspector randomly observed the ABF personnel performing the fit up tasks for the remainder of the shift.
